**Flood Control Project Maintenance
Levee Inspections**

Fall 2018 Levee Maintenance Deficiency Summary Report

Sacramento River Basin

Reclamation District No. 0307 Lisbon

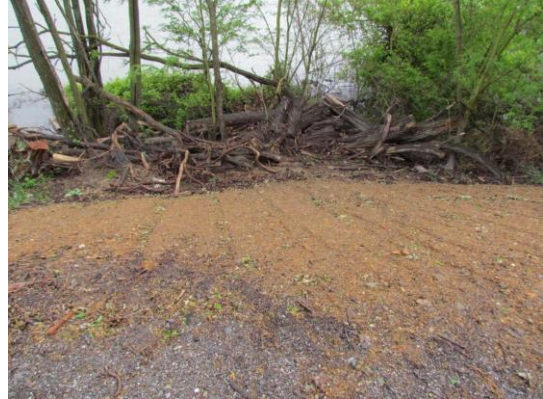
Photo 1 of 1 : FA_2018_RD0307_166_62_20180910_00014.jpg

RD 307 Levee mile 0.35 water side levee slope fallen cut up tree branches and tree sections placed at levee toe.

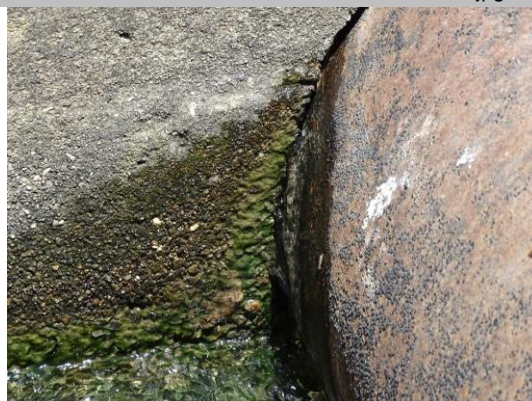
Photo 1 of 3 : UCIP_FA_2018_53336_77562.jpg

Comment Code					
Inspector Comment					
FS_ID:53336 DS_ID:21657 EP_NO: N/A Repair Type: Urgent Crossing Status: Found UCIP Comments: 06/05/2018 Same as last inspection, except the LS (sleeved) pipe at the concrete wall was grouted. WS pipe outlet shows leakage from outside the pipe; concern for erosion around pipe and within the levee. This crossing remains Urgent and recommend this crossing receive a thorough inspection by the owner (D. Sanoski - DWR UCIP)12/07/2016 Same as last inspection. The bottom portion of the pipe has several holes through the wall. Recommend owner stop use of crossing. Owner will need to coordinate with CVFPB to comply with Title 23 requirements. (O. Magana - DWR UCIP)07/31/2013 Pipe heavily corroded and will likely need replacement if 15-inch pipe sleeved through it needs replacement. Annular space not grouted between two pipes. (W. Wylie - DWR UCIP) FIELD_STRUCT_DESC: 15-inch steel irrigation pipe through the levee, 16.7 feet below the crown. 15-inch pipe sleeved through an existing 20-inch pipe. 20-inch pipe first recorded in the 1964 USACE O&M Manual. Pump missing from abandoned steel pier located on the waterside (WS) toe. Walkway on the waterside (WS) from shoulder to pier missing or abandoned. Concrete U-shaped outlet with flap gate is located on the landside (LS) toe. Service pole located on the LS slope with anchor. [Additional Reference(s): DWR Levee Log, 1990. USACE Sacramento O&M Manual Unit 114, October 1964, (River Mile 48.53)]. FS Date: 6/5/2018 10:02:00 AM

LS view: pipe on LS showing leak; potential for internal threat to levee.

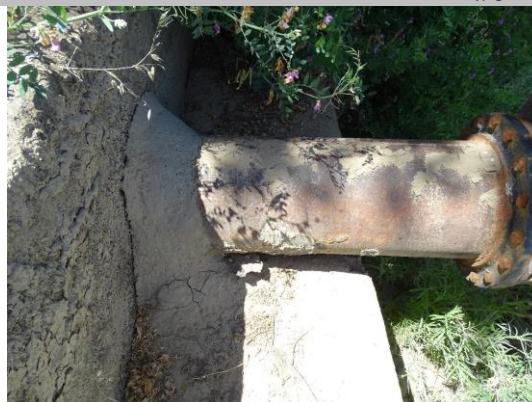
Photo 2 of 3 : UCIP_FA_2018_53336_77563.jpg

WS view: grouted sleeved pipe.

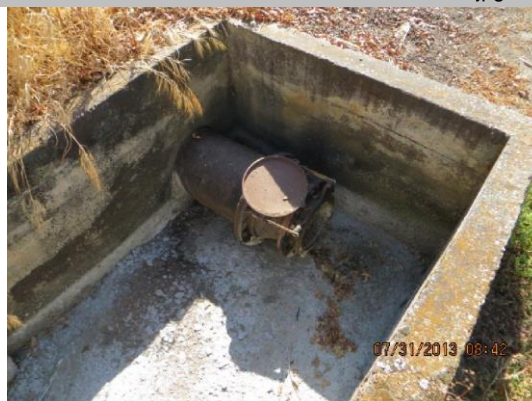
Photo 3 of 3 : UCIP_FA_2018_53336_28732.jpg

Pipe at outlet on LS toe.

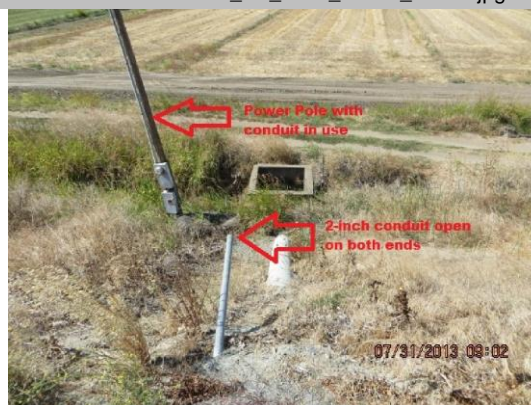
Photo 1 of 3 : UCIP_FA_2018_17103_29202.jpg

LM Start	0.93	Rating **	M	Issue No.	131
LM End	0.93	Issue Type +	En	Location *	
Category	Supplemental			GPS Latitude/Longitude	
				Start	End
Item	DWR UCIP Field Study			38.472872 °	38.472872 °
				-121.535542 °	-121.535542 °
DWR ID	24014				
Comment Code					
Inspector Comment					
FS_ID:17103 DS_ID:24014 EP_NO: 18229 Repair Type: Non-Urgent Crossing Status: Found UCIP Comments: Pipe open on both ends. Need to install caps. FIELD_STRUCT_DESC: 2 of 2: 2-inch galvanized iron electrical conduit through the levee, 2 feet below the crown. (Permit No. 18229, 2007 - Albert Martinelli). FS Date: 7/31/2013

Conduit visible 2-feet below the crown on the LS shoulder.

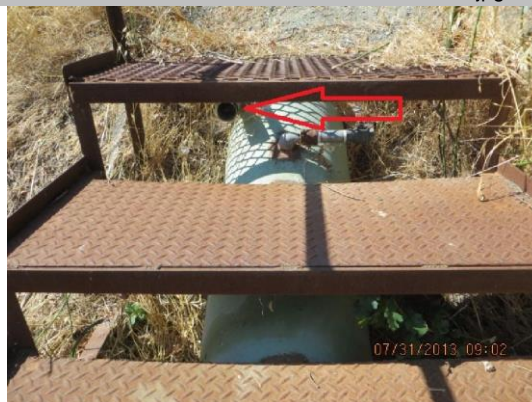
Photo 3 of 3 : UCIP_FA_2018_17103_29200.jpg

Conduit visible under first step of walkway to pump on WS shoulder.

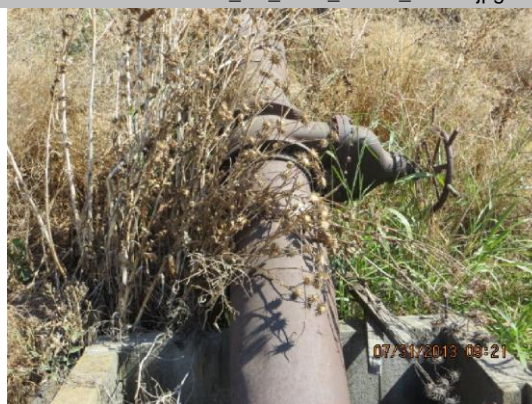
Photo 2 of 3 : UCIP_FA_2018_16764_28763.jpg

Comment Code					
Inspector Comment					
FS_ID:16764					
DS_ID:21659					
EP_NO: 8012					
Repair Type: Non-Urgent					
Crossing Status: Found					
UCIP Comments: Pipe rusted through at outlet on LS of shutoff valve. This may be good indicator or corrosion throughout pipe. This is a good candidate for video inspection.					
FIELD_STRUCT_DESC: 1 of 2: 20-inch steel irrigation pipe through the levee, 7.4 feet below the crown. Walkway from the waterside (WS) shoulder to pump on pile structure in stream. Distribution box and gate valve at the landside (LS) toe. Service pole on the LS. (Permit No. 8012, 1972 - Eula Glide Elliott). [Additional Reference(s): DWR Levee Log, 1990. USACE Sacramento O&M Manual 114, April 1959, (RM 48.53)].					
FS Date: 7/31/2013

Pipe, gate valve, and concrete distribution box on LS toe.

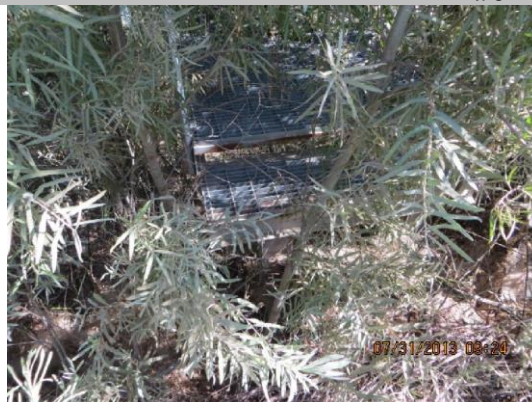
Photo 1 of 3 : UCIP_FA_2018_16766_28769.jpg

LM Start	1.08	Rating **	M	Issue No.	133	
LM End	1.08	Issue Type +	En	Location *		
Category	Supplemental			GPS Latitude/Longitude		
				Start		End
Item	DWR UCIP Field Study			38.472874 °		38.472874 °
				-121.532611 °		-121.532611 °
DWR ID	21660					
Comment Code						
Inspector Comment						
FS_ID:16766 DS_ID:21660 EP_NO: 3324 Repair Type: Non-Urgent Crossing Status: Found UCIP Comments: Walkway completely obscured by vegetation on WS slope. FIELD_STRUCT_DESC: 1.25-inch electrical conduit of an unknown material through the levee, 10 feet below the crown. Corrugated metal stage recorder house and walkway on the waterside (WS) slope. Service pole on the landside (LS) slope. (Permit No. 3324, 1960 - U.S. Department of the Interior, Surface Water Branch). [Additional Reference(s): DWR Levee Log, 1990]. FS Date: 7/31/2013

Metal walkway visible in brush on WS slope.

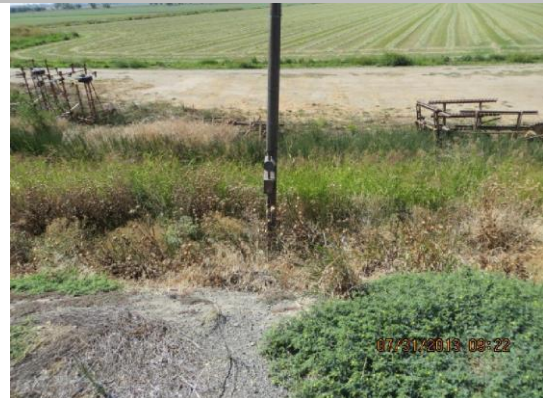
Photo 3 of 3 : UCIP_FA_2018_16766_28770.jpg

Conduit visible at base of JP on LS toe.

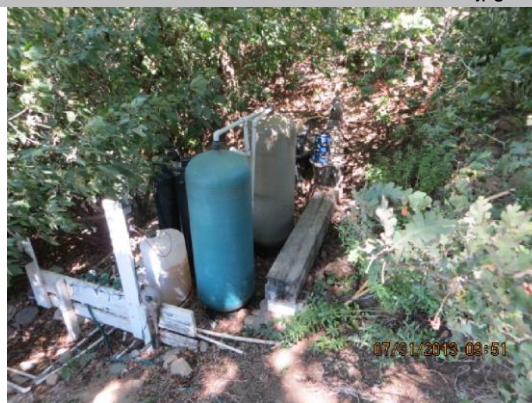
Photo 1 of 3 : UCIP_FA_2018_17105_29207.jpg

LM Start	1.62	Rating **	M	Issue No.	134
LM End	1.62	Issue Type +	En	Location *	
Category	Supplemental			GPS Latitude/Longitude	
				Start	End
Item	DWR UCIP Field Study			38.473129 °	38.473129 °
				-121.522717 °	-121.522717 °
DWR ID	24017				
Comment Code					
Inspector Comment					
FS_ID:17105					
DS_ID:24017					
EP_NO: N/A					
Repair Type: Non-Urgent					
Crossing Status: Found					
UCIP Comments: No permit identified for crossing or boat dock/steel ramp.					
FIELD_STRUCT_DESC: 2 of 2: 1.5-inch polyvinyl chloride (PVC) irrigation pipe through the levee, 2 feet below the crown. Metal walkway and pier on the waterside (WS) slope. Possible pump, filter, and tanks on the landside (LS) slope.					
FS Date: 7/31/2013

Possible pump and filter station on LS slope.

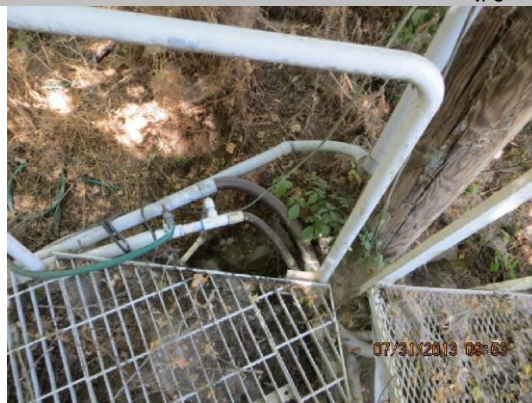
Photo 3 of 3 : UCIP_FA_2018_17105_29205.jpg

Pipes visible under walkway on WS slope.

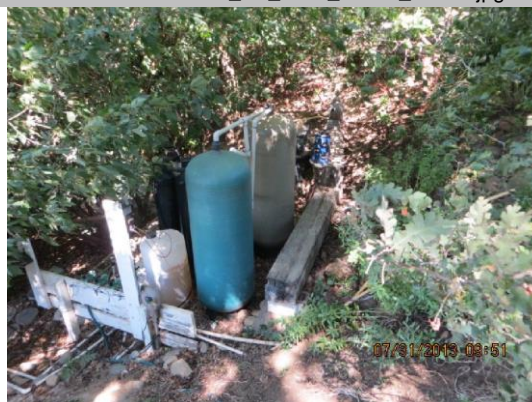
Photo 1 of 3 : UCIP_FA_2018_17106_29210.jpg

LM Start	1.62	Rating **	M	Issue No.	135
LM End	1.62	Issue Type +	En	Location *	
Category	Supplemental			GPS Latitude/Longitude	
				Start	End
Item	DWR UCIP Field Study			38.473129°	38.473129°
				-121.522717°	-121.522717°
DWR ID	24016				
Comment Code					
Inspector Comment					
FS_ID:17106					
DS_ID:24016					
EP_NO: N/A					
Repair Type: Non-Urgent					
Crossing Status: Found					
UCIP Comments: No permit identified for this crossing.					
FIELD_STRUCT_DESC: 1 of 2: 1.5-inch polyvinyl chloride (PVC)					
irrigation pipe through the levee, 2 feet below the crown. Metal walkway					
and pier on the waterside (WS) slope. Possible pump, filter, and tanks					
on the landside (LS) slope.					
FS Date: 7/31/2013

Possible pump and filter plant on LS slope.

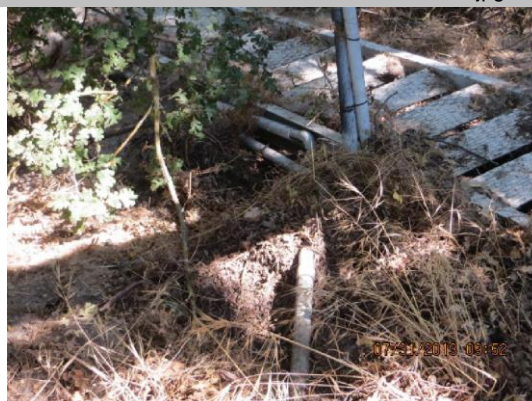
Photo 2 of 3 : UCIP_FA_2018_17106_29209.jpg

Pipes visible on WS shoulder at metal ramp.

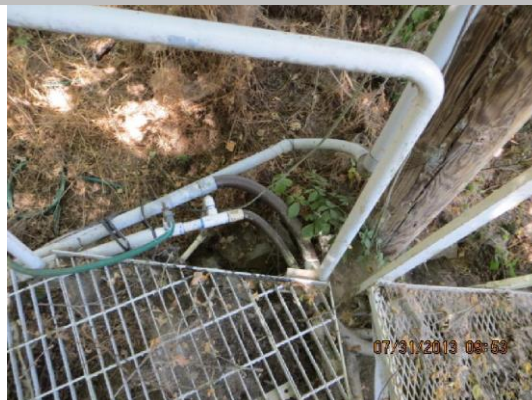
Photo 3 of 3 : UCIP_FA_2018_17106_29208.jpg

Pipes visible under metal ramp on WS slope.

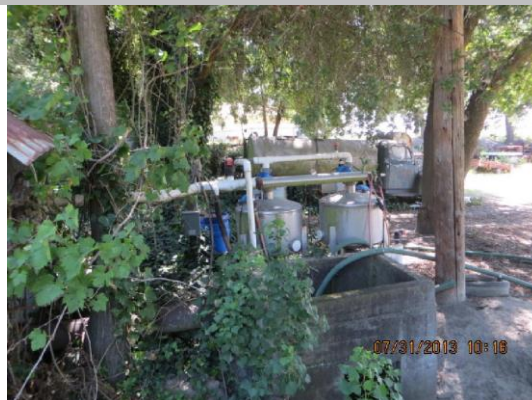
Photo 2 of 2 : UCIP_FA_2018_16805_28805.jpg

Comment Code						
Inspector Comment						
FS_ID:16805 DS_ID:21663 EP_NO: 8016 Repair Type: Non-Urgent Crossing Status: Indicator Found UCIP Comments: Needs to be abandoned properly. FIELD_STRUCT_DESC: *ABANDONED* 8-inch iron irrigation pipe through the levee, 15.7 feet below the crown. No connection in pump house on the landside (LS) toe, but 8-inch outlet pipe remains at connection from pump house to concrete standpipe. (Permit No. 8016, 1972 - Anna Gloria Serpa. Pipe capped at both ends for replacement pipe according to Permit No. 18209, 2007 - Daniel Serpa). [Additional Reference(s): DWR Levee Log, 1990. USACE Sacramento O&M Manual 114, April 1959, (RM 47.78)]. FS Date: 7/31/2013

Concrete distribution box at LS toe.

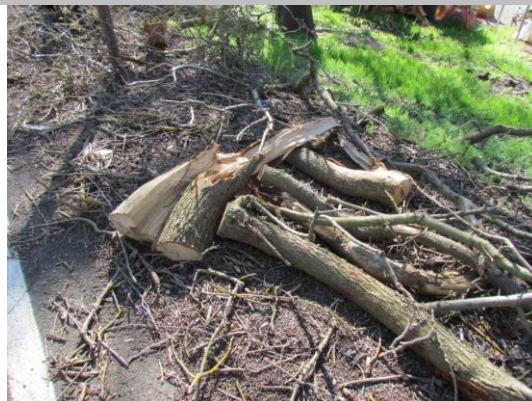
Photo 1 of 3 : FA_2018_RD0307_166_73_20180910_00016.jpg

Looking downstream from levee mile 1.86 cut up fallen tree on shoulder.

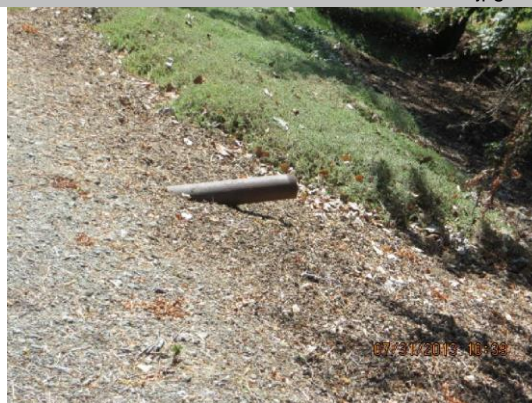
Photo 1 of 3 : UCIP_FA_2018_22709_38412.jpg

LM Start	2.21	Rating **	M	Issue No.	137
LM End	2.21	Issue Type +	En	Location *	
Category	Supplemental			GPS Latitude/Longitude	
				Start	End
Item	DWR UCIP Field Study			38.472238 °	38.472238 °
				-121.512032 °	-121.512032 °
DWR ID	21665				
Comment Code					
Inspector Comment					
FS_ID:22709 DS_ID:21665 EP_NO: N/A Repair Type: Non-Urgent Crossing Status: Found UCIP Comments: Pipe abandoned and should be done so properly. FIELD_STRUCT_DESC: 5-inch steel irrigation pipe through the levee, 2 feet below the crown. Pipe open on both ends. [Additional Reference(s): DWR Levee Log, 1990. USACE Sacramento O&M Manual 114, April 1959, (RM 47.38) (6-inch pipe listed)]. FS Date: 7/31/2013

Pipe visible on LS shoulder.

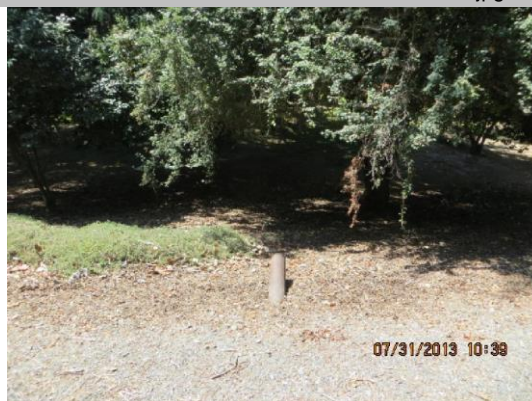
Photo 2 of 3 : UCIP_FA_2018_22709_38411.jpg

Pipe visible on LS shoulder.

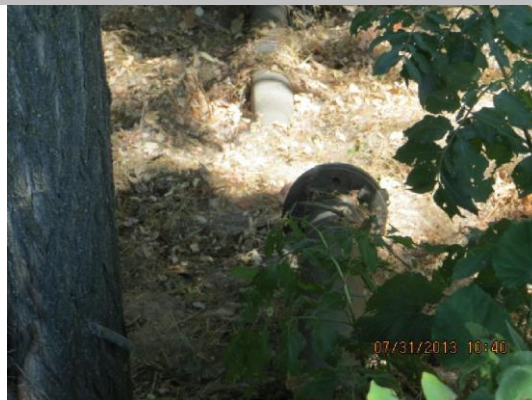
Photo 3 of 3 : UCIP_FA_2018_22709_38410.jpg

Pipe visible on WS slope.

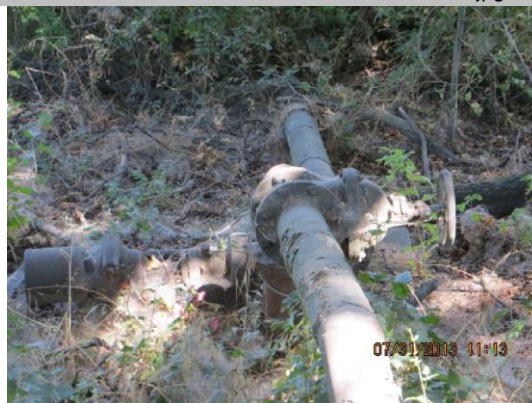
Photo 2 of 3 : UCIP_FA_2018_40794_28822.jpg

Pump and gate valve on WS slope.

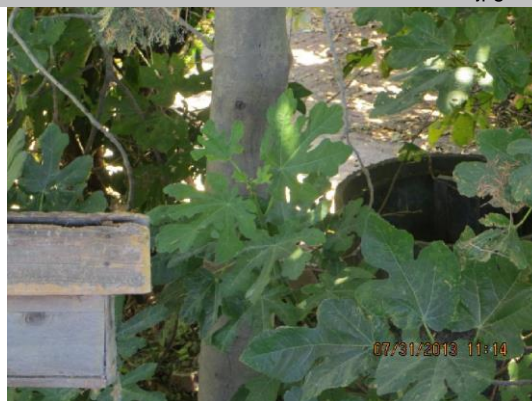
Photo 3 of 3 : UCIP_FA_2018_40794_28821.jpg

36-inch concrete standpipe on LS toe.

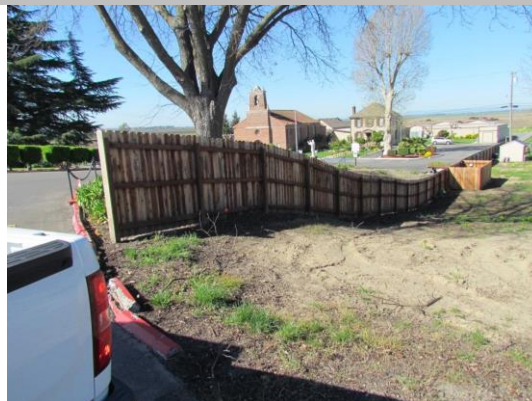
Photo 1 of 1 : FA_2018_RD0307_166_79_20180910_00019.jpg

Looking down the landside slope and shoulder of levee mile 3.19 new replacement of a solid wall wooden fence. No change.

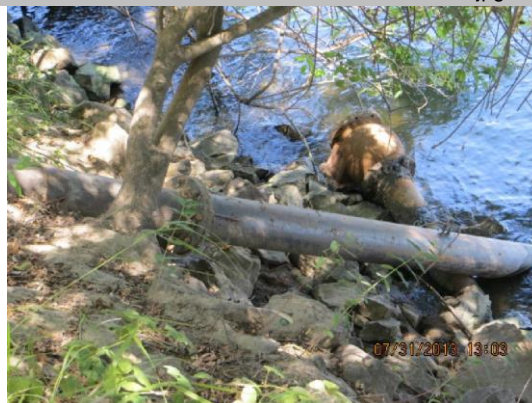
Photo 2 of 2 : UCIP_FA_2018_16843_28880.jpg

Pipe visible on WS toe.

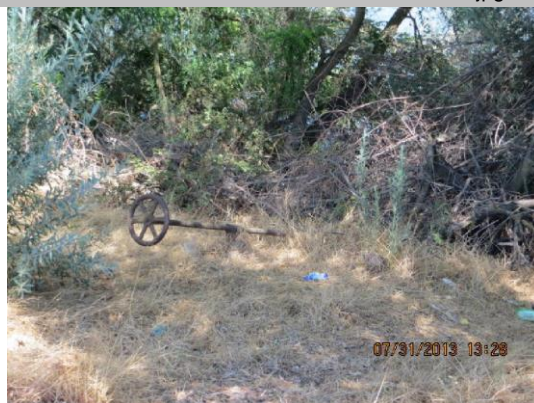
Photo 1 of 3 : UCIP_FA_2018_16923_28978.jpg

Gate valve actuator on WS slope.

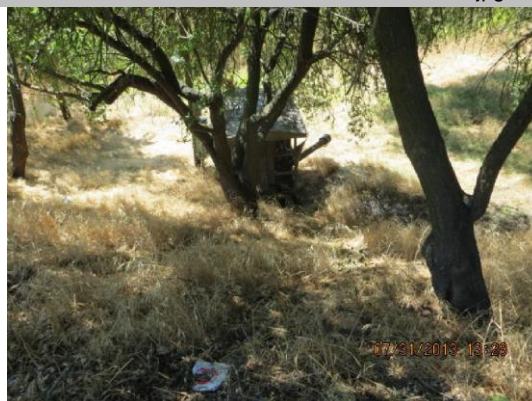
Photo 2 of 3 : UCIP_FA_2018_16923_28977.jpg

Pumphouse on LS toe.

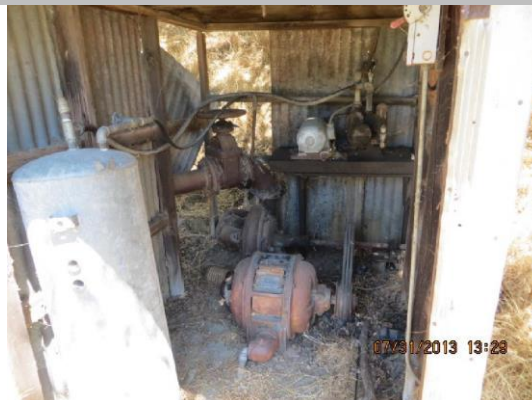
Photo 3 of 3 : UCIP_FA_2018_16923_28976.jpg

Gate valve and pump in pumphouse on LS toe.

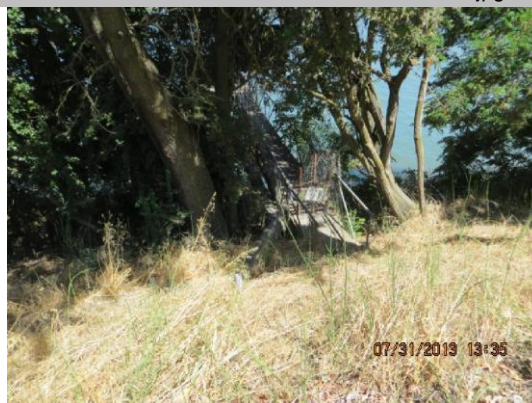
Photo 1 of 3 : UCIP_FA_2018_16924_28982.jpg

Pipe and walkway visible on WS slope.

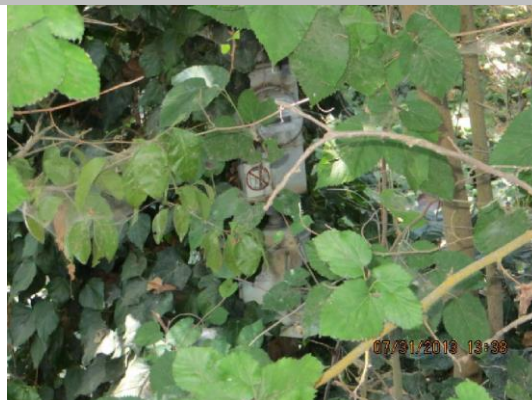
Photo 3 of 3 : UCIP_FA_2018_16924_28980.jpg

Meter on JP at LS toe covered with vegetation/IVY.

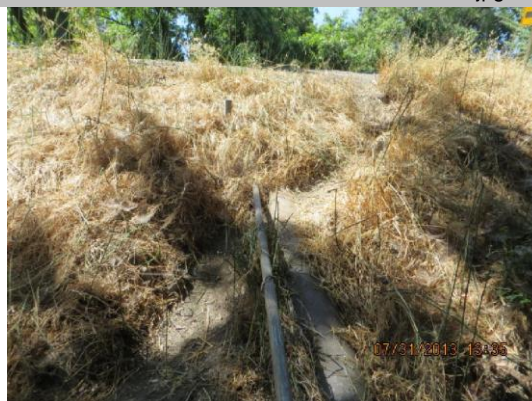
Photo 1 of 2 : UCIP_FA_2018_16925_28984.jpg

Conduit visible on WS slope.

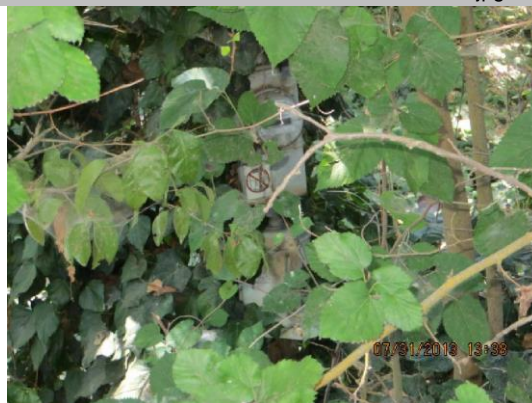
Photo 2 of 2 : UCIP_FA_2018_16925_28983.jpg

JP and meter on LS toe.

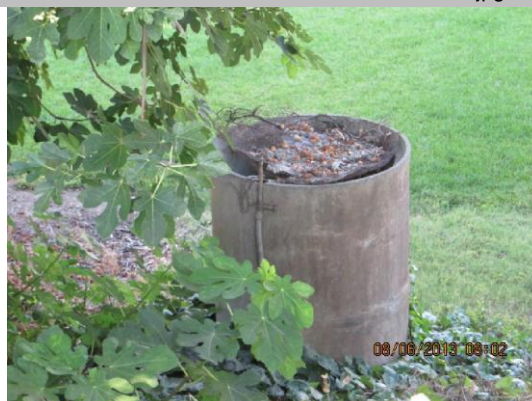
Photo 3 of 3 : UCIP_FA_2018_53338_29020.jpg

48-inch concrete standpipe on LS toe.

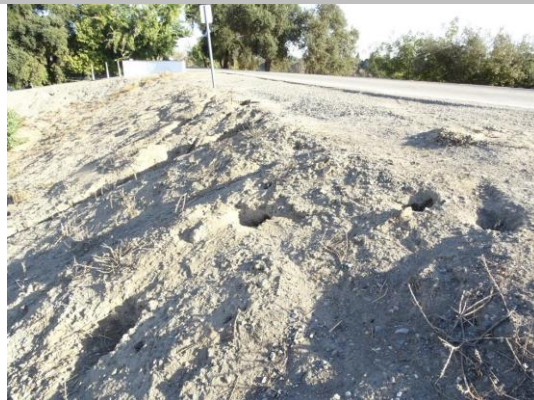
Photo 1 of 1 : FA_2018_RD0307_166_111_20181101_00117.jpg

View of rodent holes on landside slope. Fall 2018

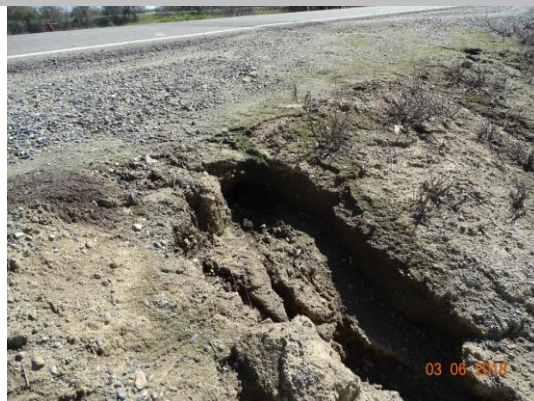
Photo 2 of 3 : FA_2018_RD0307_166_128_20180910_00034.jpg

Erosion rodent hole landside looking east. Spring 2018

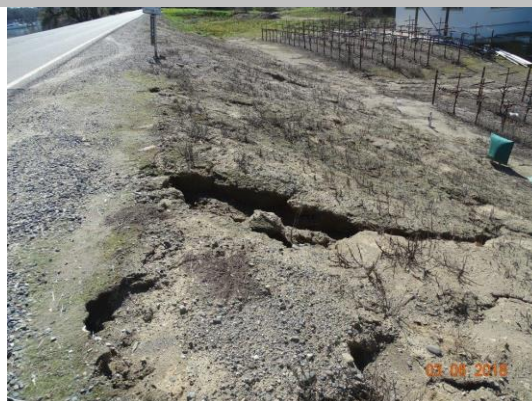
Photo 3 of 3 : FA_2018_RD0307_166_128_20180910_00035.jpg

Erosion rodent hole landside looking south. Spring 2018

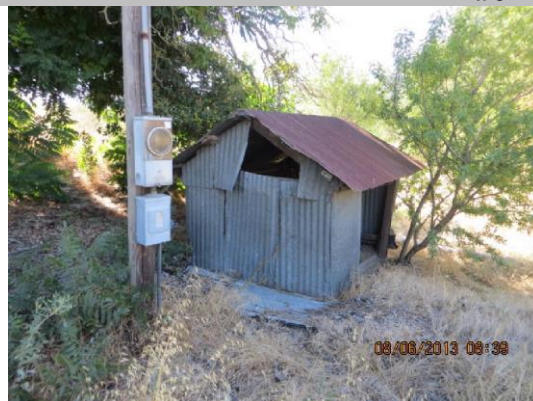
Photo 2 of 3 : UCIP_FA_2018_53339_29260.jpg

Power Pole, meter, and pumphouse on LS toe.

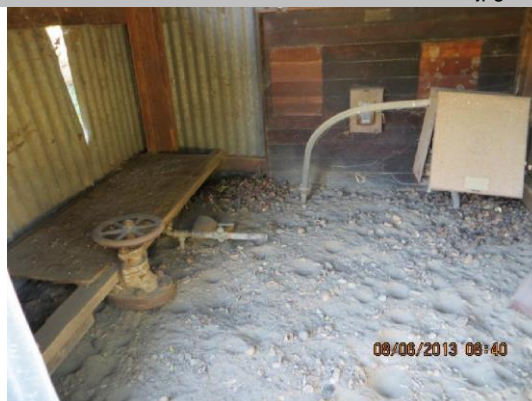
Photo 3 of 3 : UCIP_FA_2018_53339_29259.jpg

Gate valve in pumphouse on LS toe. pumphouse filled with soil.

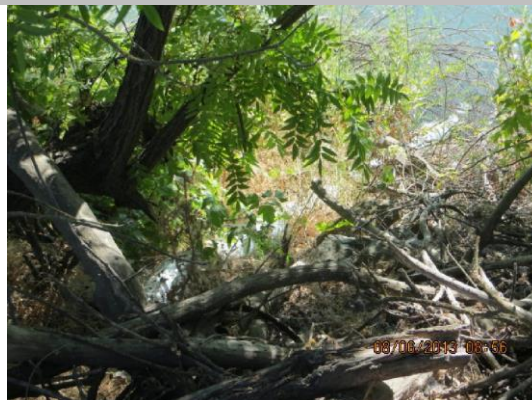
Photo 2 of 3 : UCIP_FA_2018_22670_38289.jpg

Pipe visible on WS slope.

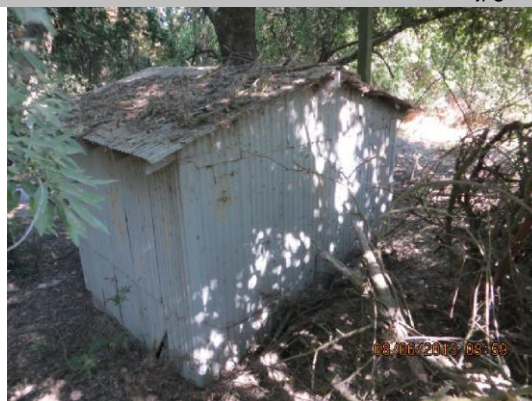
Photo 3 of 3 : UCIP_FA_2018_22670_38292.jpg

Pumphouse on LS toe.

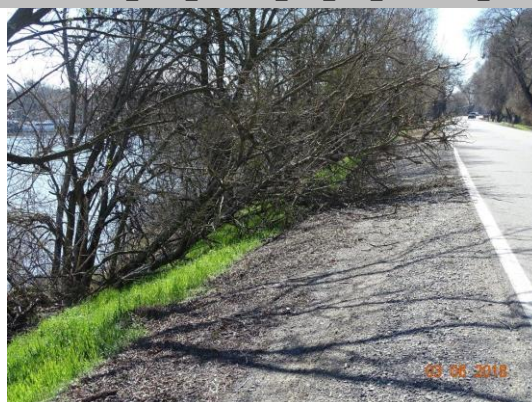
Photo 1 of 1 : FA_2018_RD0307_166_119_20180910_00032.jpg

Downed tree waterside looking south.

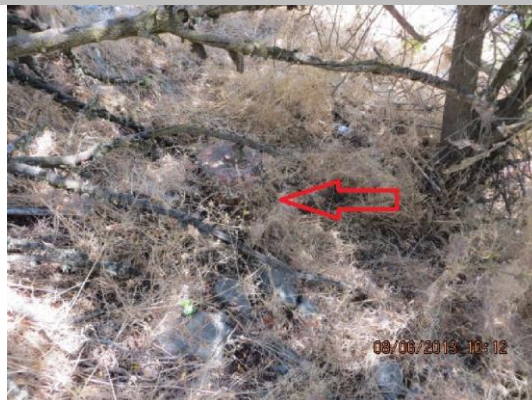
Photo 2 of 3 : UCIP_FA_2018_17183_29320.jpg

Gate valve on WS slope.

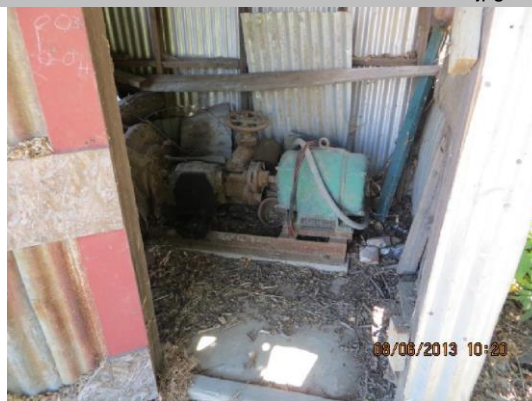
Photo 3 of 3 : UCIP_FA_2018_17183_29323.jpg

Pump in pumphouse on LS toe.

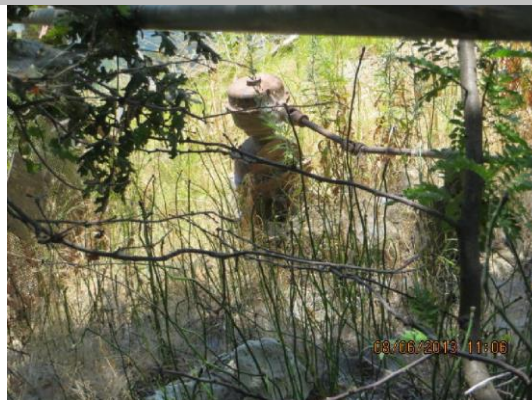
Photo 2 of 3 : UCIP_FA_2018_17184_29325.jpg

Gate valve on WS slope.

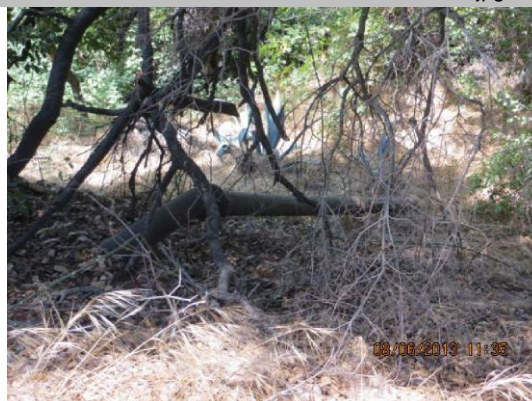
Photo 1 of 1 : UCIP_FA_2018_22671_38293.jpg

Pipe visible on LS slope.

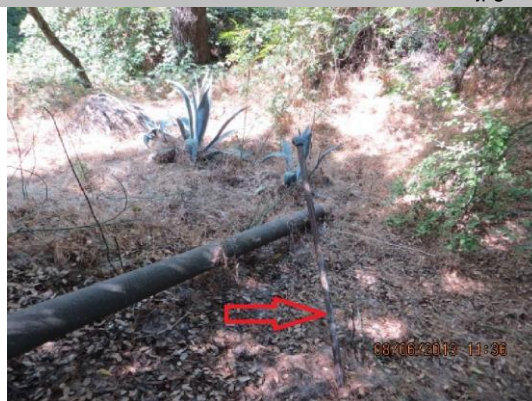
Photo 1 of 1 : UCIP_FA_2018_22672_38296.jpg

Abandoned electrical conduit next to pipe on LS slope.

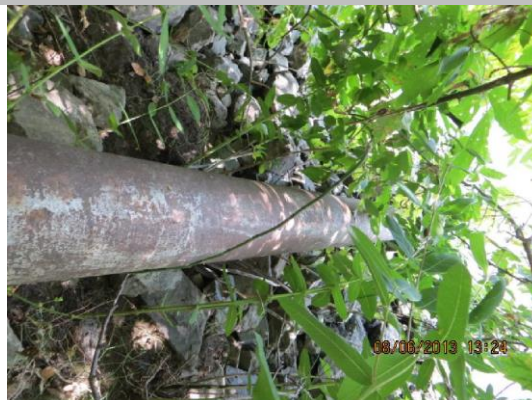
Photo 2 of 3 : UCIP_FA_2018_22710_38414.jpg

Pipe visible on WS slope.

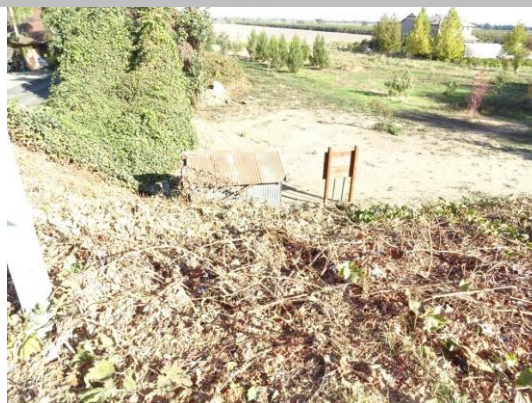
Photo 1 of 1 : FA_2018_RD0307_166_58_20181101_00119.jpg

View of shed at levee toe. Fall 2018

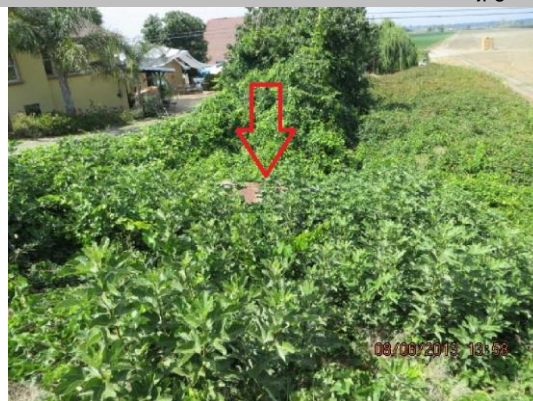
Photo 1 of 2 : UCIP_FA_2018_40546_29421.jpg

Pumphouse on LS toe.

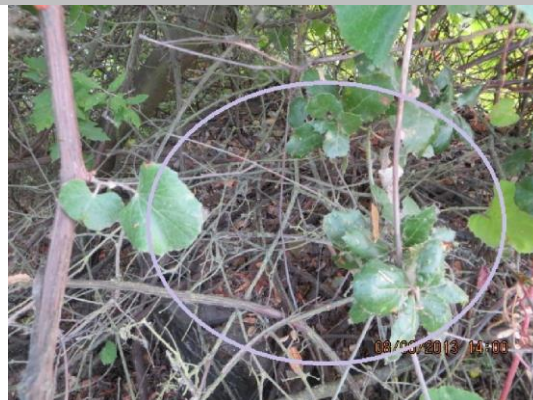
Photo 2 of 2 : UCIP_FA_2018_40546_29420.jpg

Gate valve in 5-foot diameter CMP riser on WS slope.

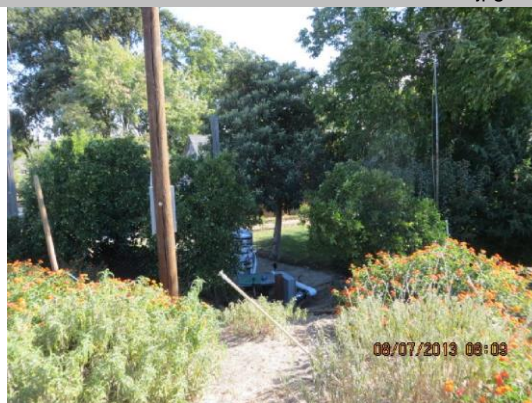
Photo 1 of 3 : UCIP_FA_2018_17287_29423.jpg

Pump and appurtenances on LS toe.

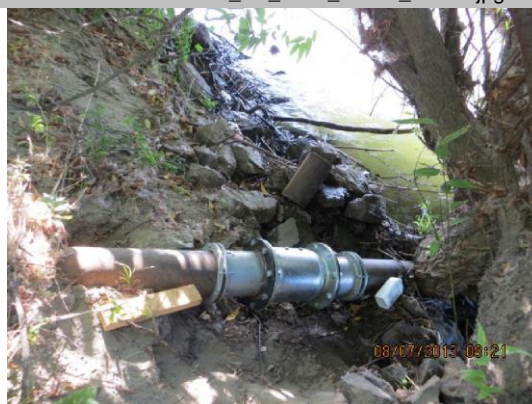
Photo 3 of 3 : UCIP_FA_2018_17287_29425.jpg

Pipe visible at WS toe.

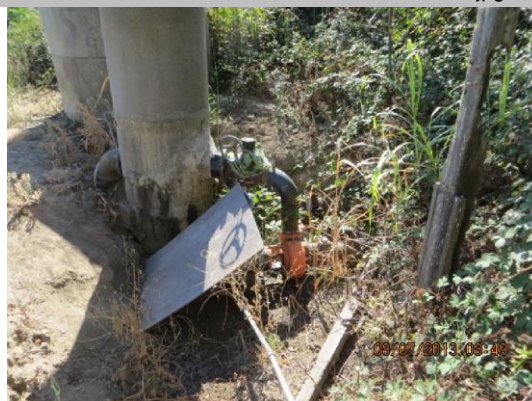
Photo 3 of 3 : UCIP_FA_2018_17343_29440.jpg

Pump, butterfly valve, vent, and concrete standpipe on LS toe. Photo 3 description or comment here.

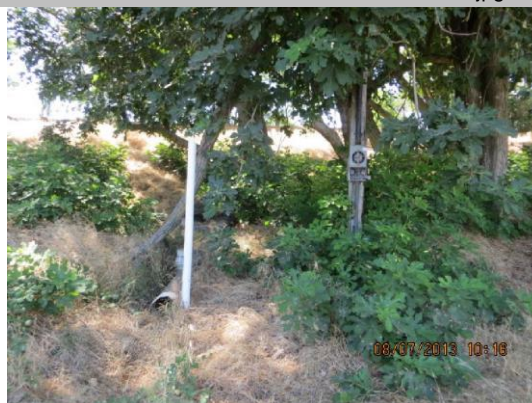
Photo 1 of 2 : UCIP_FA_2018_22711_38419.jpg

Power pole and meter off LS toe.

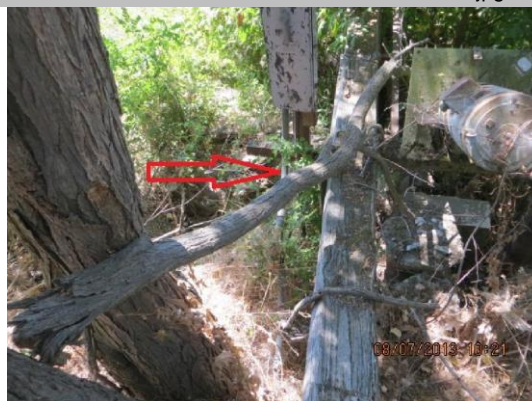
Photo 2 of 2 : UCIP_FA_2018_22711_38418.jpg

Electrical conduit visible at panel next to slant pump on WS slope.

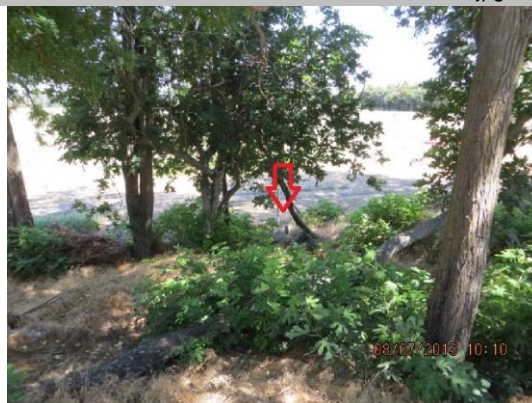
Photo 1 of 3 : UCIP_FA_2018_22712_38422.jpg

Pipe on LS toe.

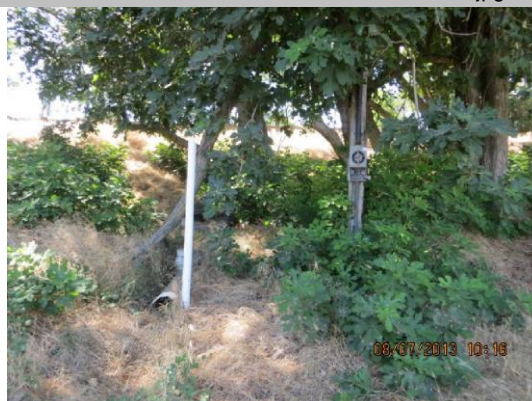
Photo 2 of 3 : UCIP_FA_2018_22712_38421.jpg

Pipe, power pole, and meter on LS toe.

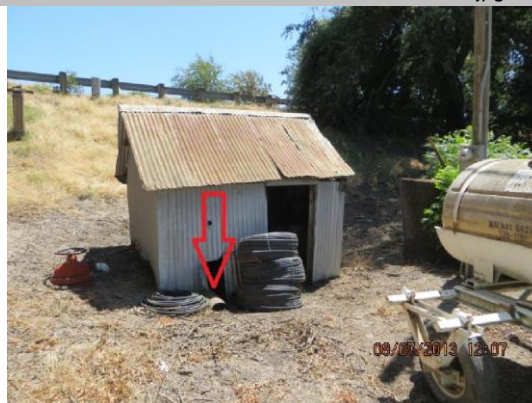
Photo 3 of 3 : UCIP_FA_2018_17385_29487.jpg

Pipe cut and open on LS of pumphouse.

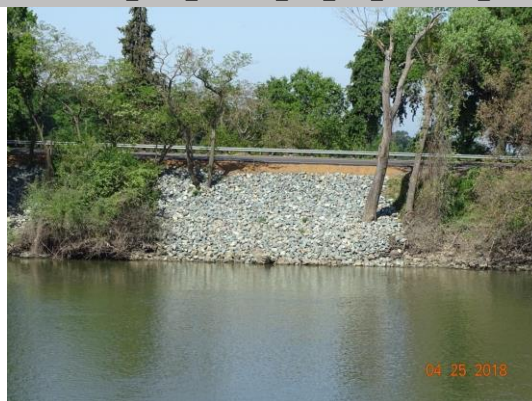
Photo 1 of 2 : FA_2018_RD0307_166_107_20180910_00028.jpg

RD307 Lisbon Unit 1 Issue 107 LM6.42-6.55 Erosion repaired picture taken from LB looking west.

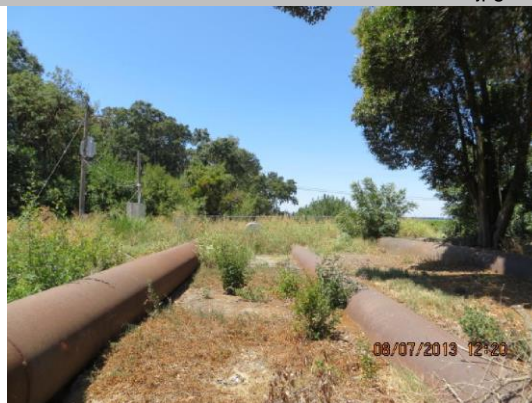
Photo 1 of 3 : UCIP_FA_2018_17404_29504.jpg

Pipe visible on LS toe to pumping plant 200-feet off LS toe.

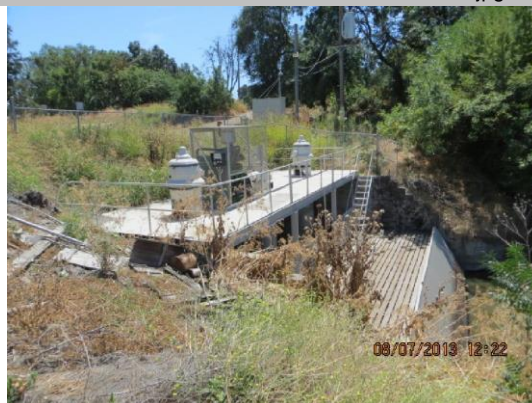
Photo 2 of 3 : UCIP_FA_2018_17406_29509.jpg

Pump and trash rack 200-feet off LS toe.

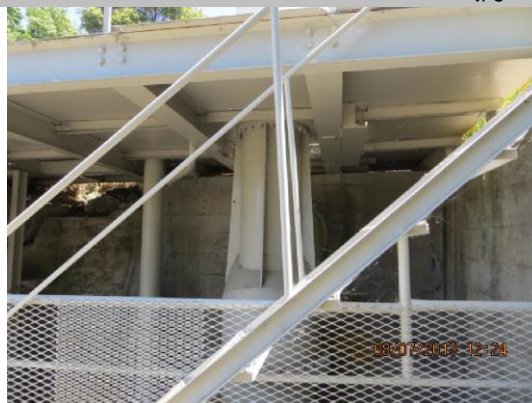
Photo 3 of 3 : UCIP_FA_2018_17406_29508.jpg

Intake at concrete headwall under pump.
